## **IMPROVING RAMP DESIGN AS A BARRIER-FREE ACCESS IN PUBLIC BUILDINGS IN THE KUMASI METROPOLITAN AREA, GHANA**

### **ABSTRACT**

**Keywords:** Ramp Design; Barrier-free; Accessibility; Public Buildings; Kumasi; Ghana

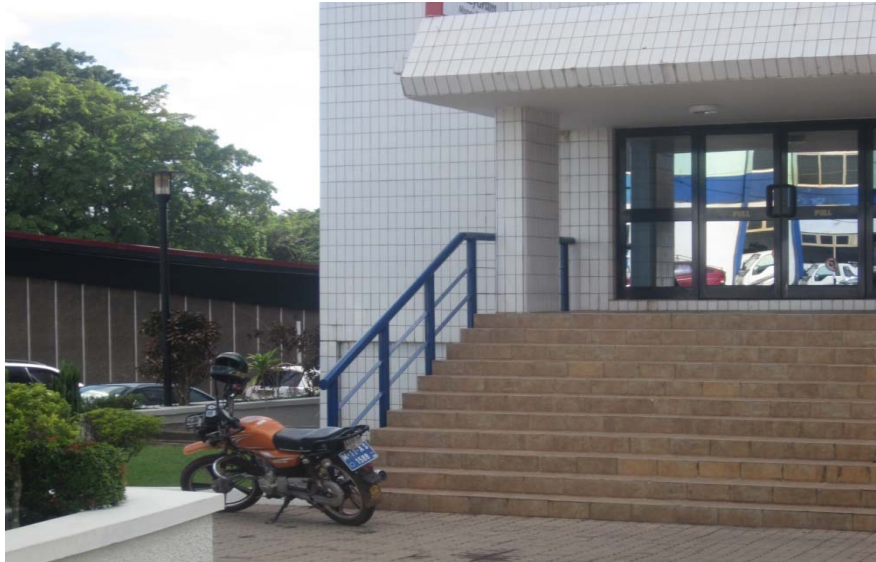
Until the passage of the Disability Law in June 2009 in Ghana, the pursuit of institutional framework for legislation towards the development of facilities to meet the needs of the physically challenged had not been a prime consideration. This is in spite of the fact that the provision of special access and rails was made mandatory for all public buildings as part of the law. Consequently, there are physical barriers regarding movement and utilization of public, social and communal facilities. Though there are a number of storey buildings which have incorporated elevators to aid movement from one floor to the other, the entrances have only a flight of stairs thus hindering access from the forecourt to the ground floor as shown in Figure 1.

**Figure 1: Entrance of a public building with no ramp provided**

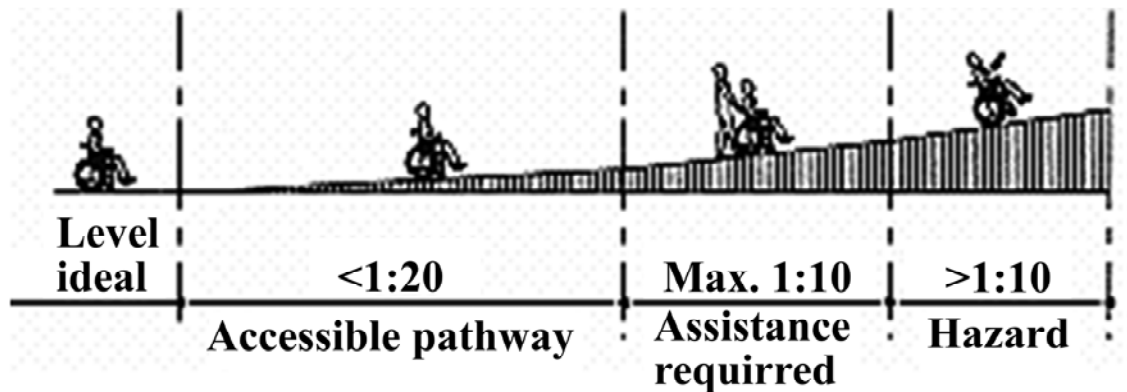
resulting in a flexible and more universally accessible design (CMHC, 2011). According to the Centre for Accessibility Environment (CAE) (2011), ramps, both external and internal, connecting different levels need to be designed and detailed with care if they are to have real practical value. When the topography or the configuration of an existing building is restrictive, variations may be done to the gradient as a function of the ramp length (United Nations, 2003). Slopes beyond 1:10 become hazardous even for people who are physically fit. Recommended minimum and maximum ramp slopes by the United Nations are shown in Figure 2.

**Figure 2: Minimum and Maximum Ramp Slopes**

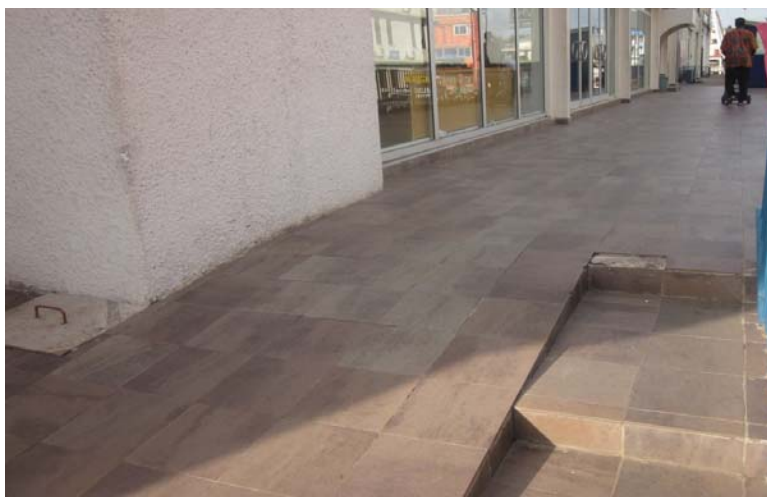
ADA (2002) indicates that, thresholds should not be placed at the doors and that if there is a requirement for making thresholds, then its height should not exceed 25mm. Thresholds studied from the field ranged between 50mm and 100mm and were not levelled to facilitate passage of wheelchairs. The accessibility of about 80% of buildings with ramps in place is limited due to barriers posed by relatively high thresholds at the doorway. Figures 3 and 5 show the entrance of a public building with a relatively high door threshold that confronts users after ascending a ramp.

**Figure 3: High thresholds at a main entrance doorway**

- Finished floor levels at entrances should be increased to either remove thresholds or reduce them to the recommended maximum height of 25mm;
- The Ministries, Departments and Agencies responsible for the built environment should initiate measures to remove the obstacles to participation in the physical environment by persons with disabilities. Such measures should lead to the development of standards and guidelines and to consider enforcing laws to ensure accessibility to various areas in society, such as housing, commercial buildings, and other outdoor environments;

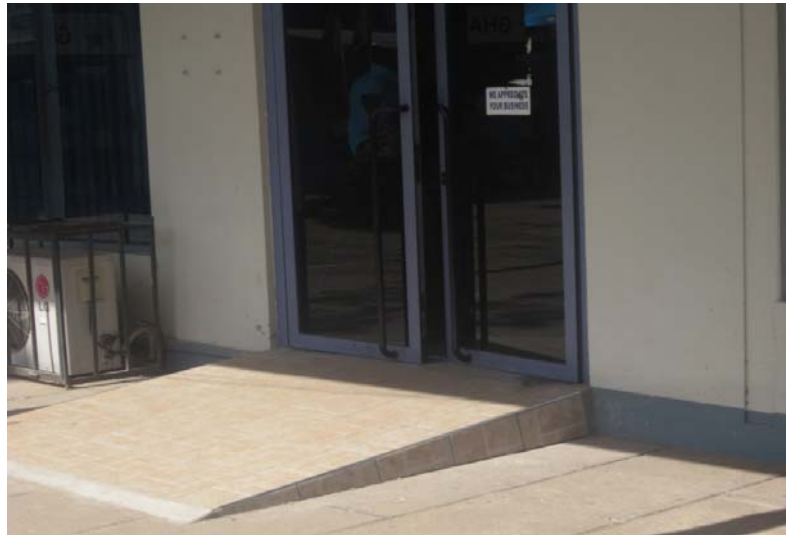
Most of the landings have the same width as the ramp; however, the lengths are shorter than the recommended size of 1,525mm. Data from the field survey revealed that 25% of the buildings studied had no landing before the entrance as the ramps run directly to the threshold at the door. Even though these ramps did not need to have a landing because the total vertical rise of 440mm was less than the recommended value, the absence of the landing before the door caused wheelchair users and ambulant persons to tip backwards as they stop on the sloping surface of the ramp to open the door (Figure 4). About 95% had a total horizontal running distance of less than the recommended 760mm (see Table 2) for which no intermediate landing is required. It was further observed that about 20% of the landings were less than the recommended dimension of 1,525mm by 1,525mm to allow manoeuvring and turning by users. Only one building had an intermediate landing as a result of the use of an L-shaped ramp design arising from restricted space.

**Figure 4: Ramp running directly to threshold of door with no landing**

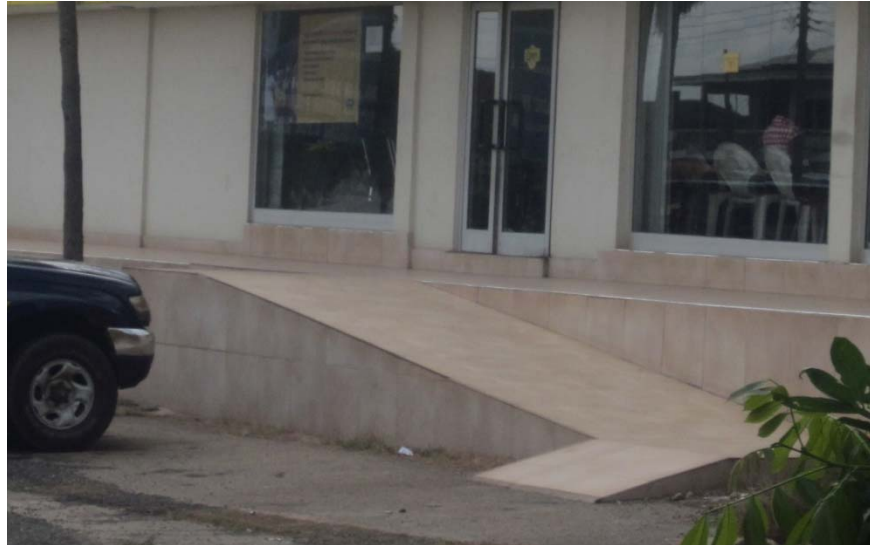
If a ramp has a rise greater than 150mm or a horizontal projection greater than 1,830mm, then it shall have a handrail on both sides (ADA, 2002). The handrails should be firmly fixed with the top properly shaped and placed safely to provide guidance, balance and support to users. About 45% of the ramps surveyed had handrails on either the left or the right side, with 10% having handrails on both sides of the ramp, and 45% of the ramps had no handrails. Though their vertical rising height is greater than 150mm and the horizontal projection is greater than 1,830mm, 45% did not have handrails on both sides and some had no handrails at all (Figure 5).

**Figure 5: Ramp with no guiding handrails for users**
