EROSION PROBLEMS IN A NIGERIAN RURAL COMMUNITY

By: Ajewole Davies Ojo & Oni Johnson

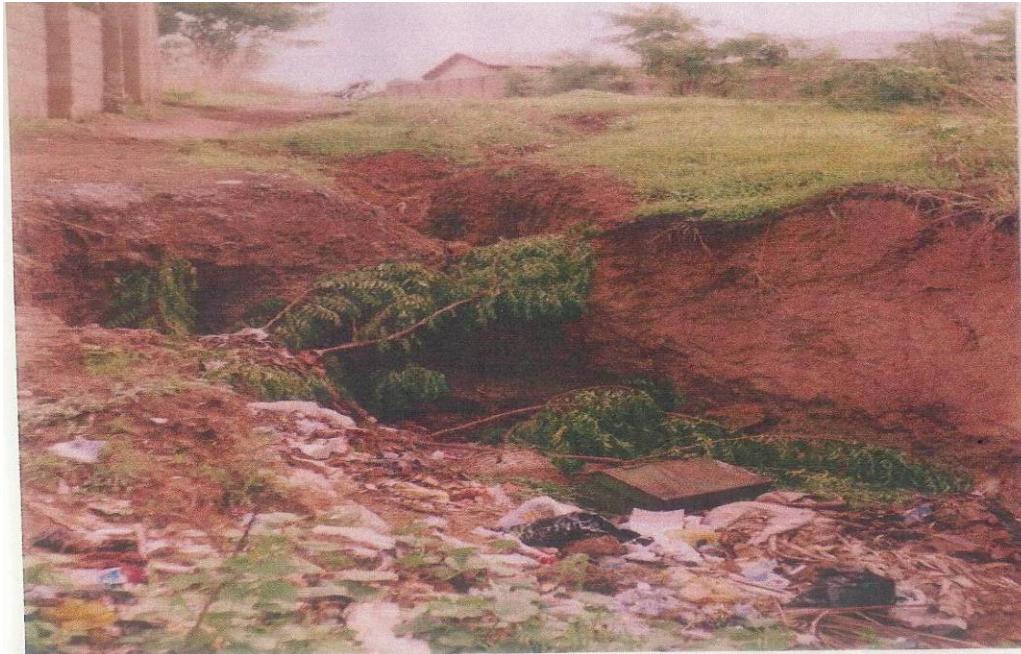
Fig. 2. Gully Erosion site in the Study Area.

Plate 1: An open space severely affected by gully erosion along Koro grammar School.

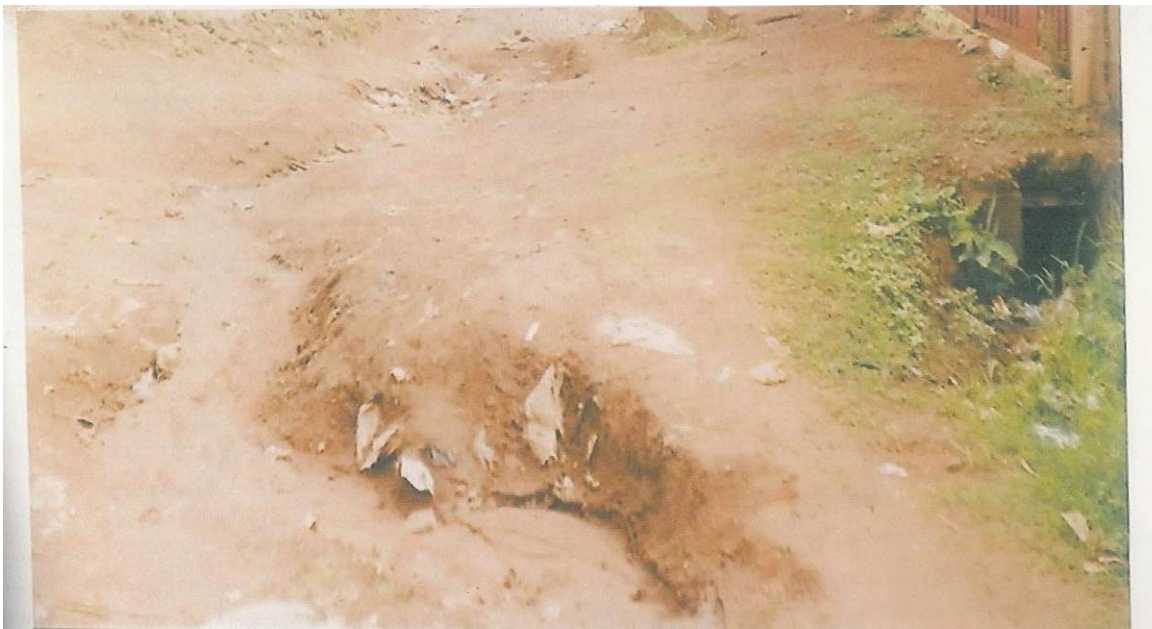
Fig. 3. Road network Erosion site in the study area

Plate 2: Road network that is almost washed-off by water erosion along the ECWA dispensary road, Koro. The width of the road has become so reduced that is almost impassable for four wheeled vehicles.

Fifthly, in view of the contribution of road construction to increase erosion problem in Nigeria, it is recommended that the Federal, State and Local Government should provide adequate

drainage system along all the roads and ensure adequate maintenance of these road network systems.
